Chelsea Welker
GEOG 5340 – Final paper
August 3, 2016

A mitigation perspective on three GIS case studies on post-fire debris flows along the Wasatch Front, Northern Utah

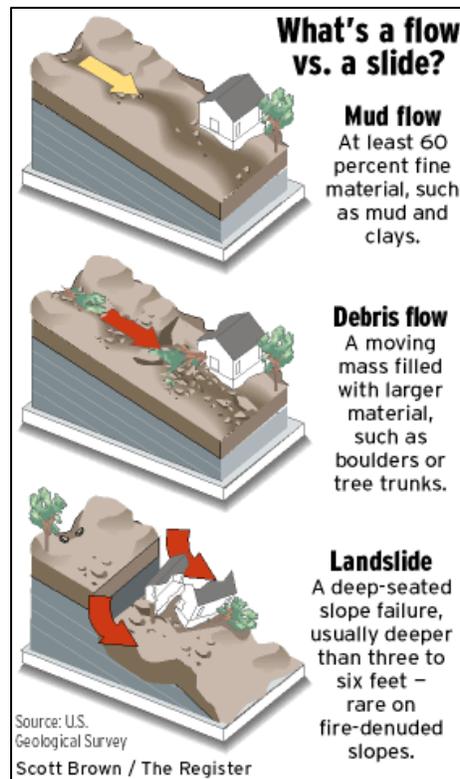
Figure 1. Description of landslide types (USGS).

debris flow hazards. Utah is also a very arid which creates a high susceptibility to wildfires. The combination of these risks are post-fire debris flows. In recent history, Utah landslides have caused more than \$261 million in damage (Eldridge et al. 2008). Debris flows are a type of landslide that contain larger debris, such as tree trunks or boulders, and can travel long distances quickly (USGS, Figure 1).

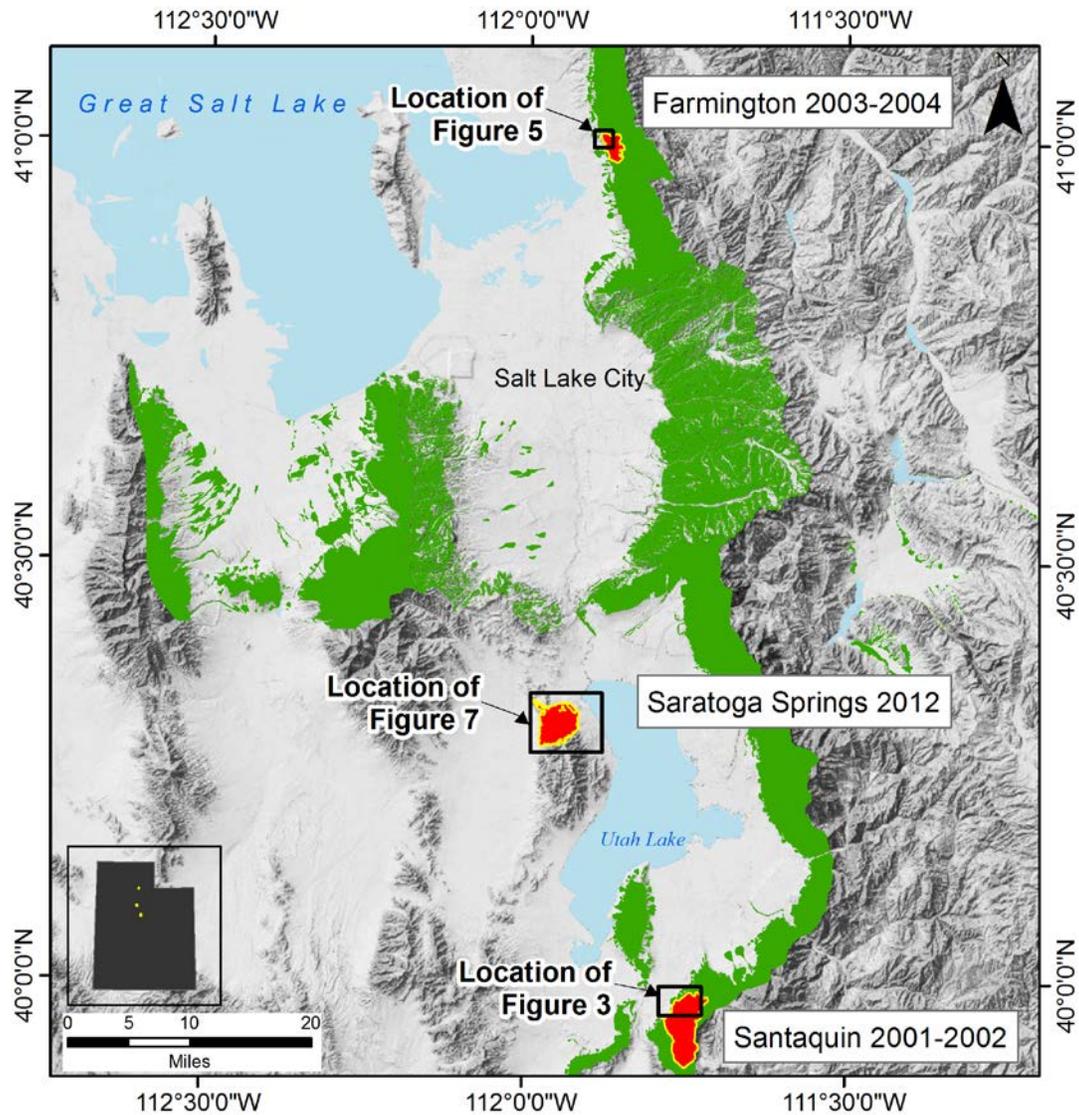
Figure 2. Base map showing debris flow hazard areas (green) and fire perimeters (red) for the three case studies along the Wasatch Front, northern Utah. Boxes indicate locations of Figures 3, 5 and 7. Hillshade data from the Utah AGRC.

The locations of the wildfires and subsequent debris flows are in Figure 2.

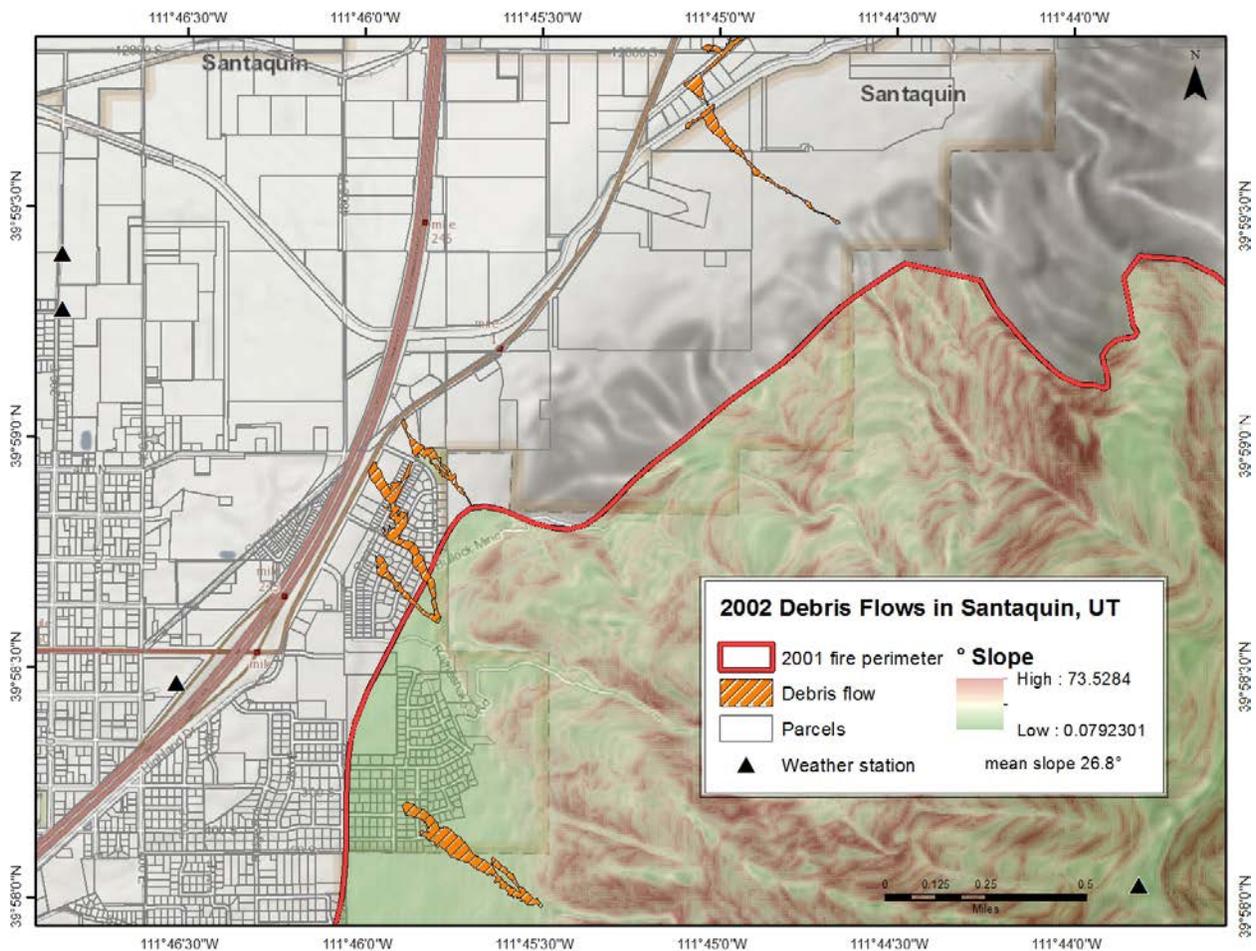
Figure 3. Index map of the debris-flows from 2002 for Santaquin, Utah. See Figure 2 for location.

The “Mollie” wildfire occurred in Utah County near the city of Provo (Figure 3) in August 2001 and burned approximately 8,000 acres. The burn scar was seeded and mulched by the U.S. Forest Service but it didn’t take root quickly enough. A post-fire mitigation plan to build diversion channels to offset landslide hazards was planned but wasn’t completed due to time and financial restraints (Giraud and McDonald, 2002).

On September 12, 2002 the post-fire debris flow occurred releasing more than 20,000 cubic yards of sediment on the residents below that lived in the path of drainage channels (Giraud and McDonald, 2002). Rainfall from the previous day of 0.58 inches triggered the event. The soil type was loam. The landslide took place on the west side of Dry Mountain, at the foothills of the Wasatch Front, with an average slope of 26.8° (Figure 3). As is normal with quick traveling debris-flows, there was little warning and structure damage occurred.

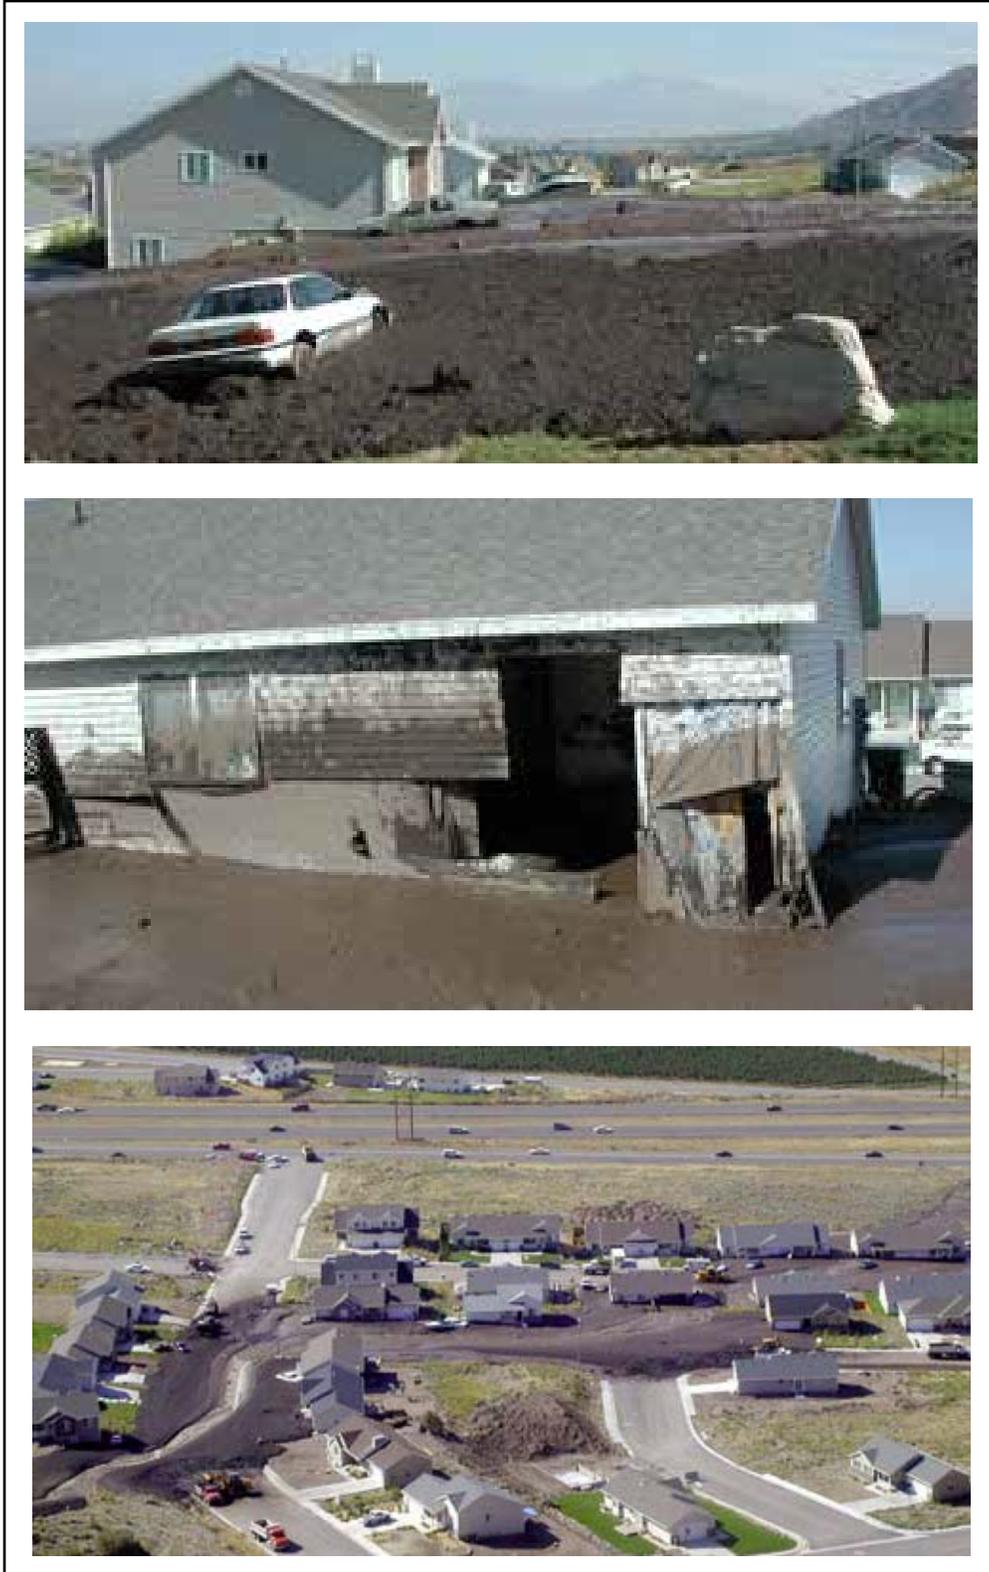
Figure 4. Photos of damage from the Santaquin 2002 debris flows (Utah Valley University).

No injuries or deaths were reported but the debris flow caused damage to 20 houses, taking 3 off their foundations (McInerney, 2009) and caused approximately \$500,000 in damage (Giraud and McDonald, 2002). ArcGIS analysis determined that 89 parcels (from 2000 census) intersect the debris flows. Figure 4 shows examples of damage from the debris flows. Census data from 2000 reveals that an average of 4 people live per house and home values average approximately

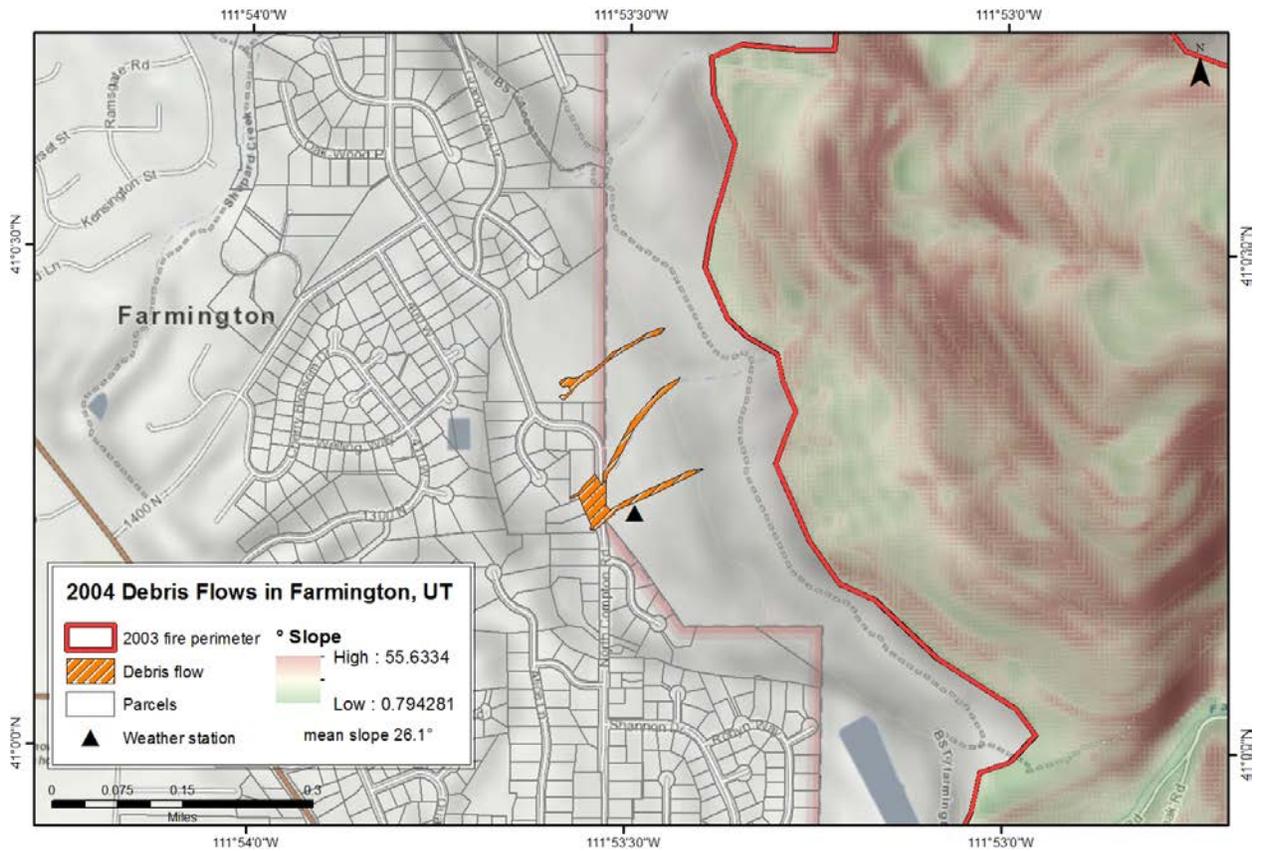
Figure 5. Index map of the debris-flows from 2004 for Farmington, Utah. See Figure 2 for location.

The Farmington wildfires occurred in Farmington of Davis County (Figure 5) in late August 2003 and burned approximately 1,800 acres. Landslide mitigation measures were recommended including planting vegetation and some diversion structures were already in place as previous precautions.

The debris flow in Farmington occurred a year later on April 6, 2004. Approximately 4,000 cubic feet of sediment flowed down to the residents (Giraud and McDonald, 2002). The triggering rainfall the day before was 1.58 inches and the average slope steepness was 26.1° for the burned area. The soil type was gravelly loam.

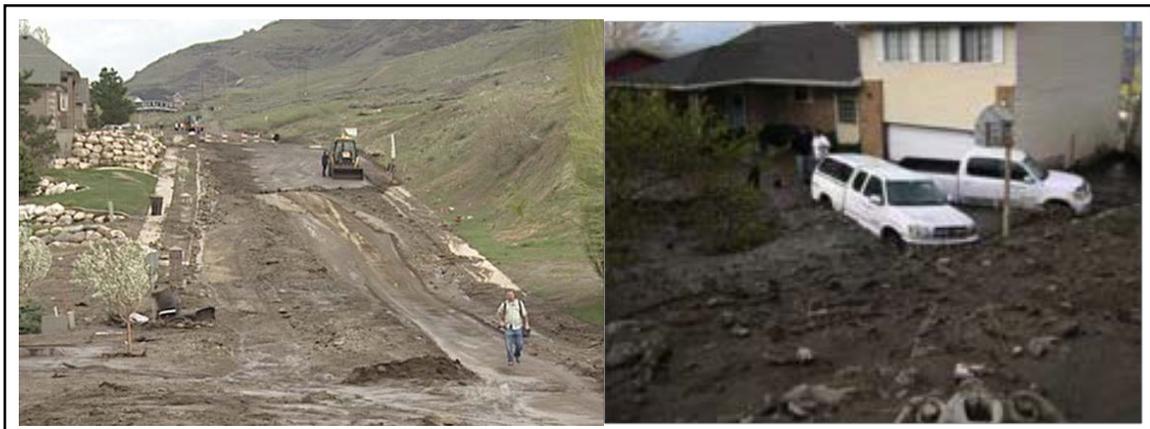
Figure 6. Photos of damage from the Farmington 2004 debris flows (KSL and UEN).

No one was injured but the flow damaged multiple homes, property and infrastructure (Giraud and McDonald, 2002 and McInerney, 2009). ArcGIS analysis indicates 4 parcels (from 2000 census) intersect the debris flows. Figure 6 shows debris flow damage photos. Davis County has the highest incident rate of debris flows than any other along the Wasatch Front (Giraud). This long-standing history of landslide hazards provokes a quick response time from multiple agencies including the Utah Geological Survey, the U.S. Forest Service and the U.S. Natural Resources Conservation Service and most of the larger drainage basins have protective measures. Smaller ones, such as the Farmington in 2004 debris flow did not. Census data from 2000 state that there are about 4 people living per household and with an average home value of \$255,000.

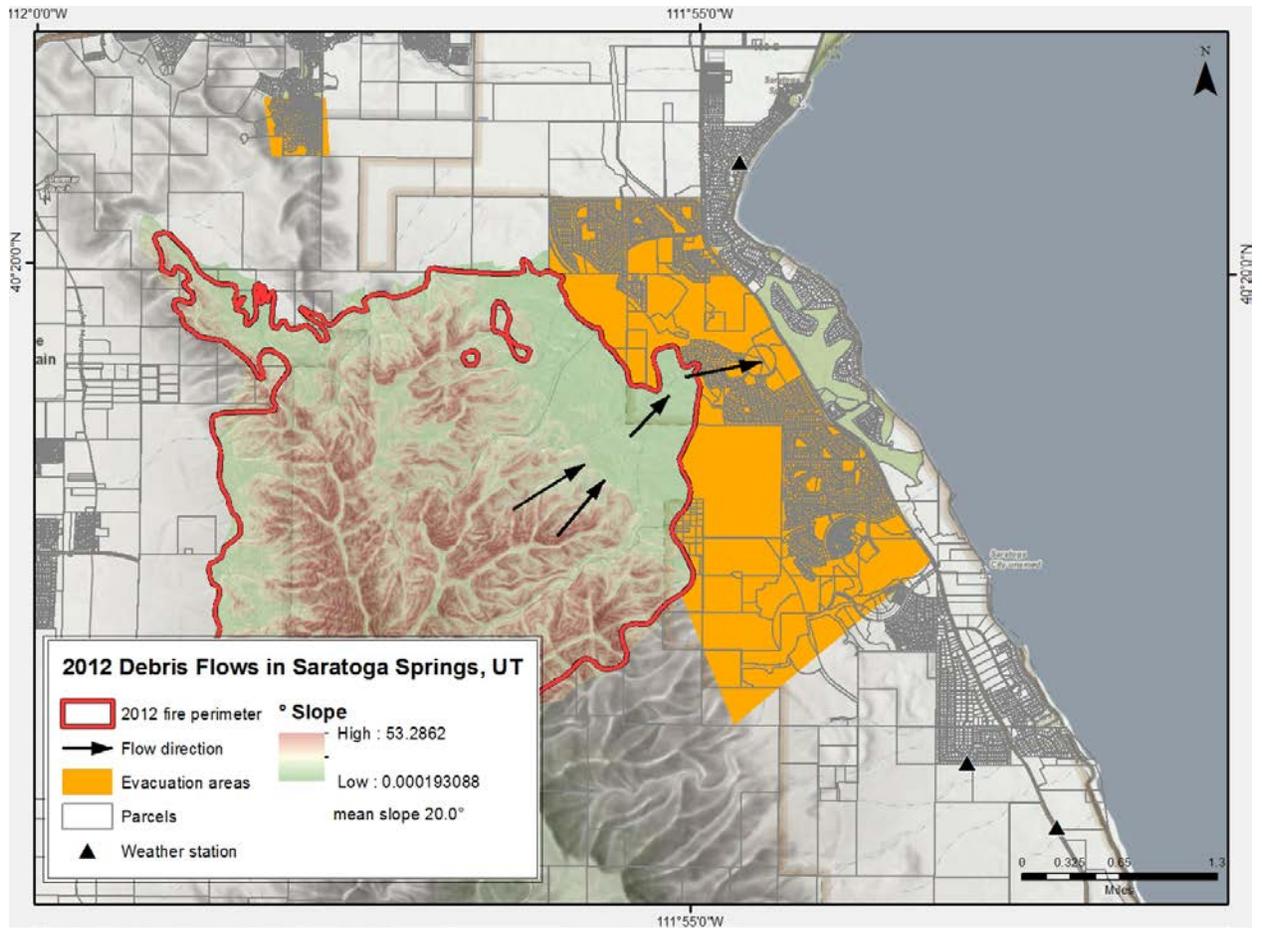
Figure 7. Map of the debris-flows from 2012 for Saratoga Springs, Utah. See Figure 2 for location.

The “Dump” Fire or Saratoga Springs Fire burned 6,000 acres in June 2012 near the community of Saratoga Springs and Eagle Mountain, in Utah Country (Figure 7). After the fire, emergency assistance was requested to install mitigation measures, but the debris-flow occurred just a few months after the fire, before anything could be installed.

The debris-flow occurred on September 1, 2012 in Israel Canyon above the Saratoga Springs community. It unleashed approximately 11,000 tons onto the residential area (out of the 70,000 tons released) and prompted the evacuation of 9,000 people. Rainfall of 1.25 inches during twenty-five minutes, triggered the event. The average slope of the burn scar was just 20.0° (Todea, 2015). The soil type was stony loam. ArcGIS analysis indicate 2889 parcels intersect the approximated evacuation zone.

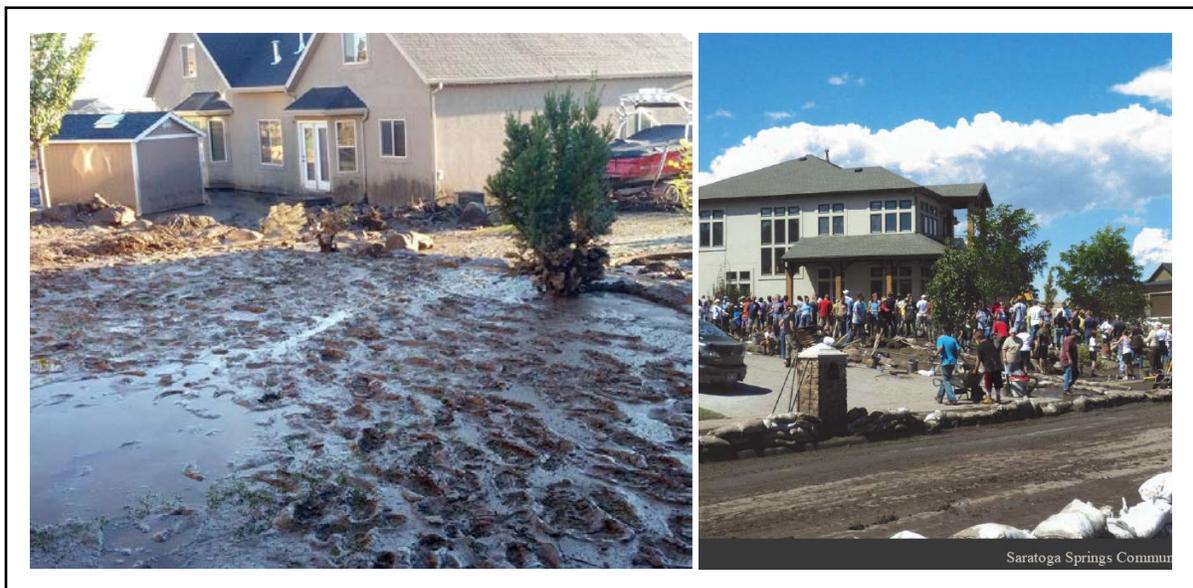
Figure 8. Photos of debris flow damage from Saratoga Springs, 2012 (DEM)

The debris-flow flooded basements with mud and damaged houses but there were no injuries. Figure 7 shows examples of damage from the debris flow. After the debris flow there have been numerous mitigation projects including improving existing drainage channels, clearing out the overfilled detention basin, creating spillways etc. According to the 2010 census data, an average of 4 people live in a residence with average homes values at \$268,000.
